# A-6 Intruder

# WALK AROUND

**By Lou Drendel**

**Walk Around Number 2  
squadron/signal publications**

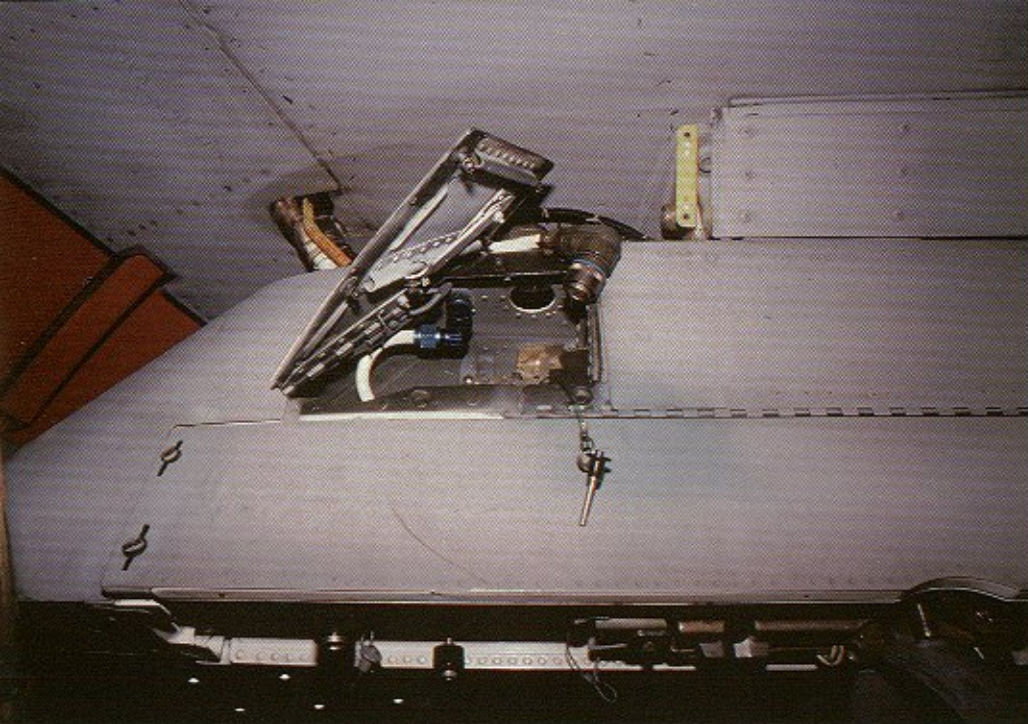
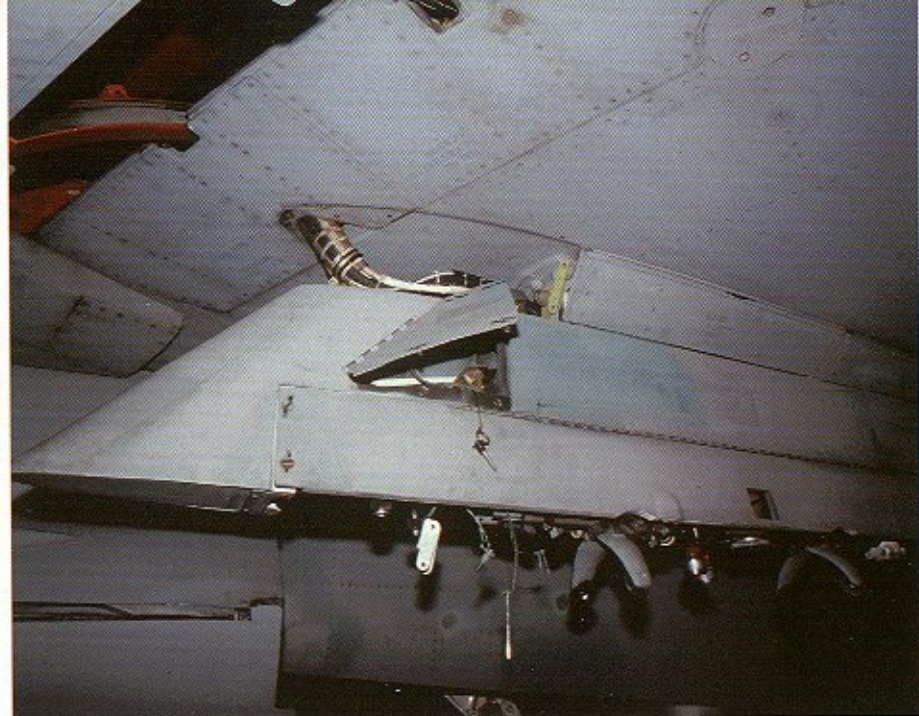
The open access panel on the inboard weapons pylon on an A-6E reveals the electrical connections for the pylon, wiring conduits, bomb/drop tank sway braces and fasteners.

The additional fairing on the outboard side of the outboard weapons pylon covers part of the wing fold mechanism.

This is the inboard pylon on an A-6A with all panels closed and fastened down. Each pylon has two sets of sway braces to help keep whatever is hung on the pylon from shifting.

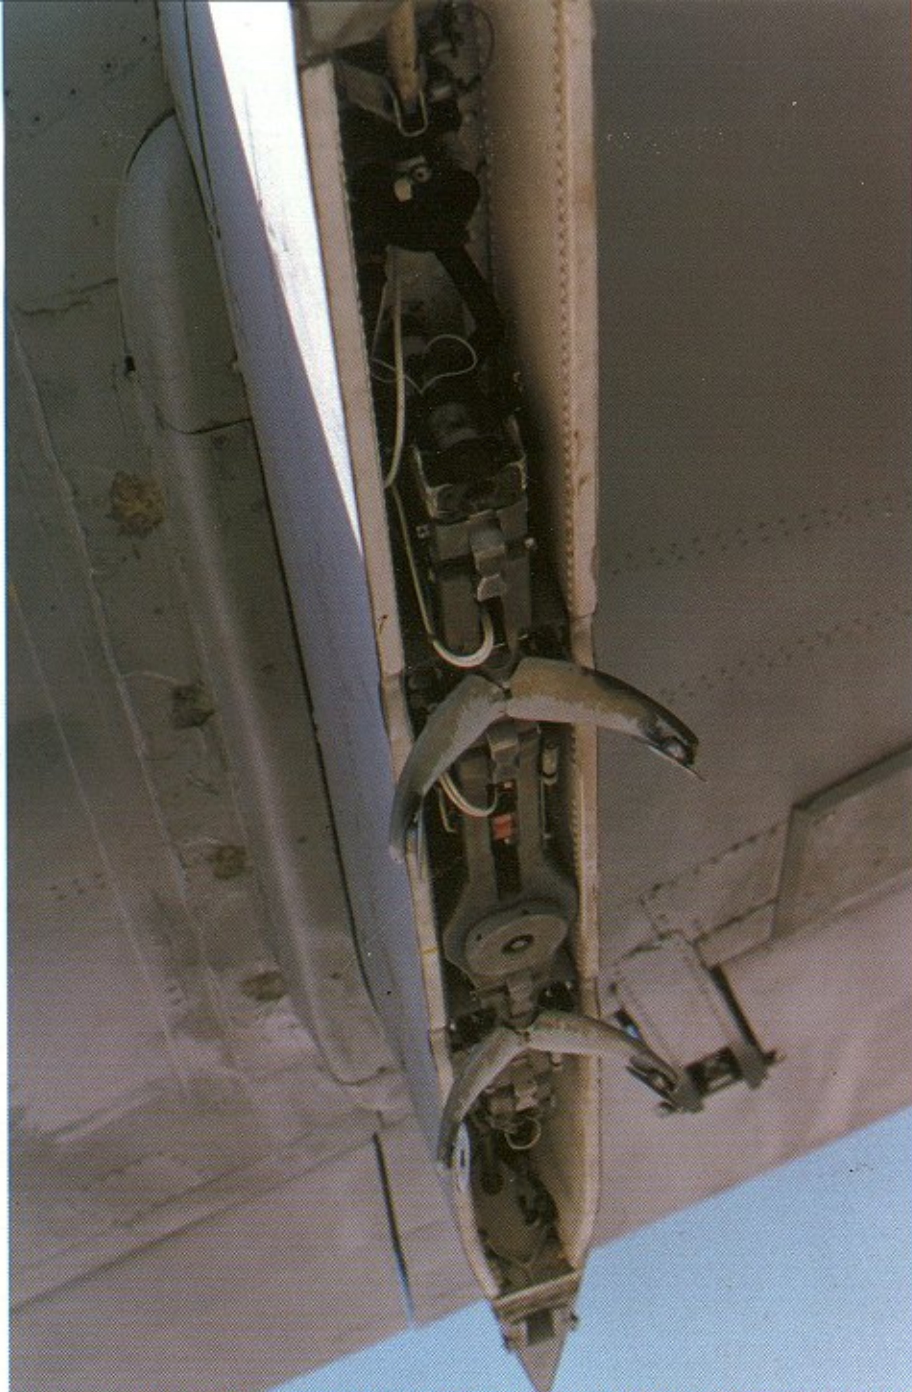
The circular object between the sway braces is the ordnance rack attachment lug. In addition to bomb racks and weapons, the pylons have the necessary plumbing for fuel tanks.

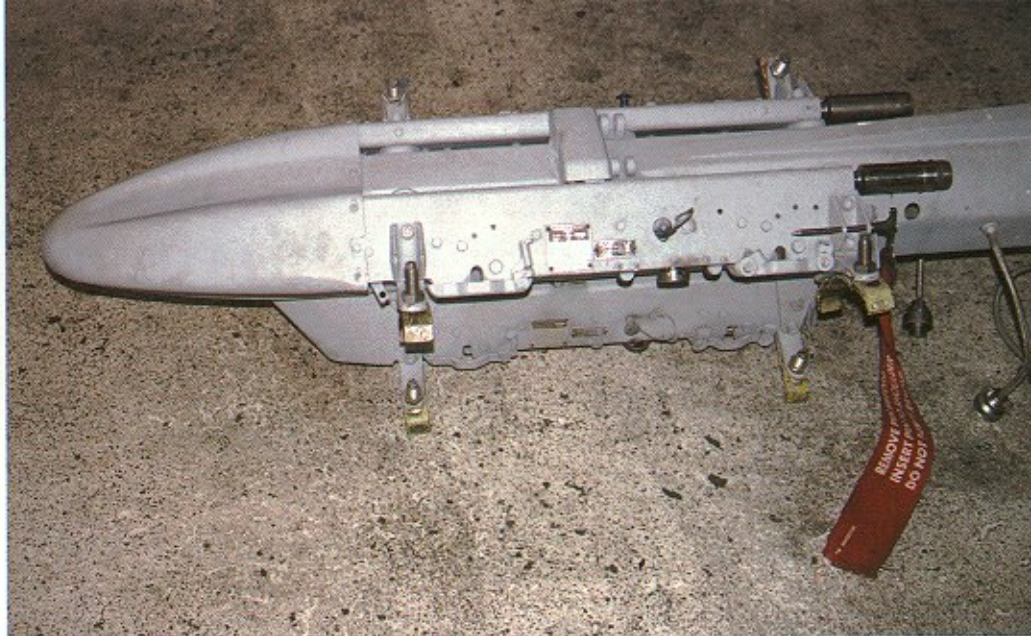
The Multiple Ejector Rack (MER) is capable of carrying six bombs, three on the forward portion and three on the rear portion. It can be carried on any of the standard A-6 weapons pylons. The suspension lugs are in the center of the rack.

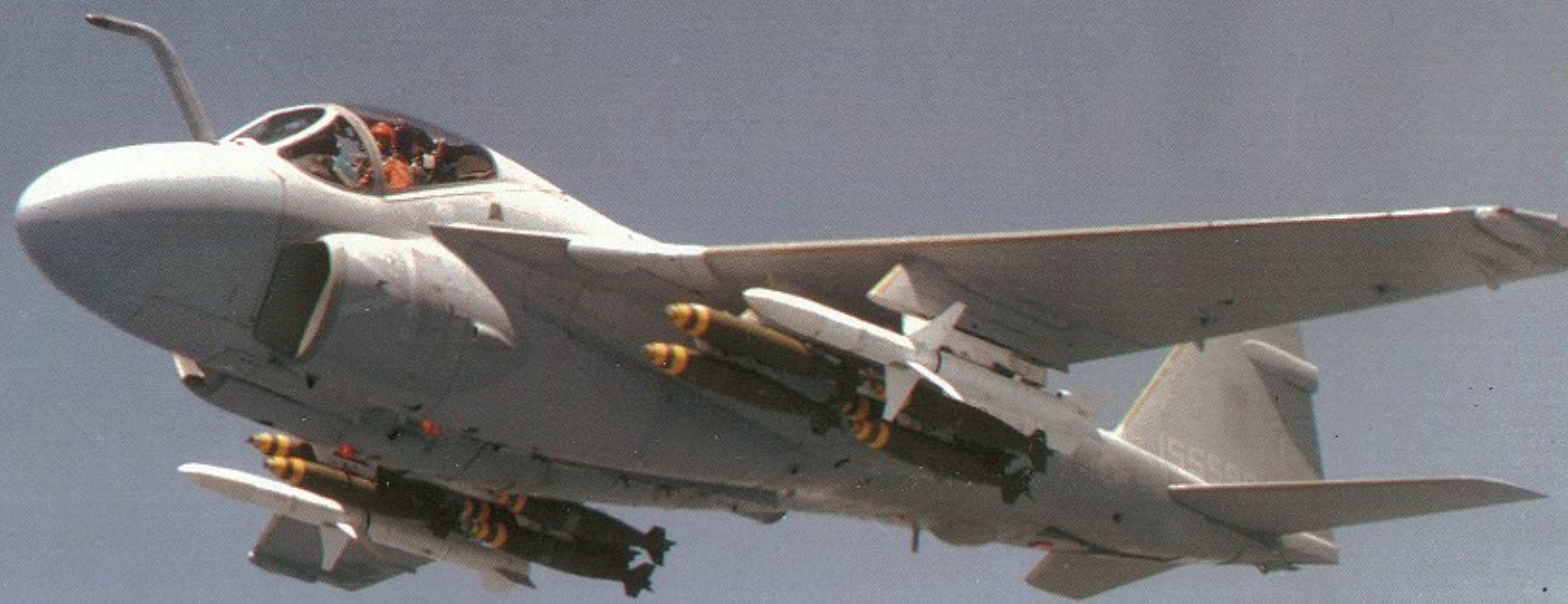
This A-6E is loaded with a pair of AGM-88 HARM anti-radiation missile and twelve Mk 83 general purpose low drag bombs. The A-6E can carry a wide variety of weapons including rockets, missiles, cluster bombs, iron bombs and smart weapons.

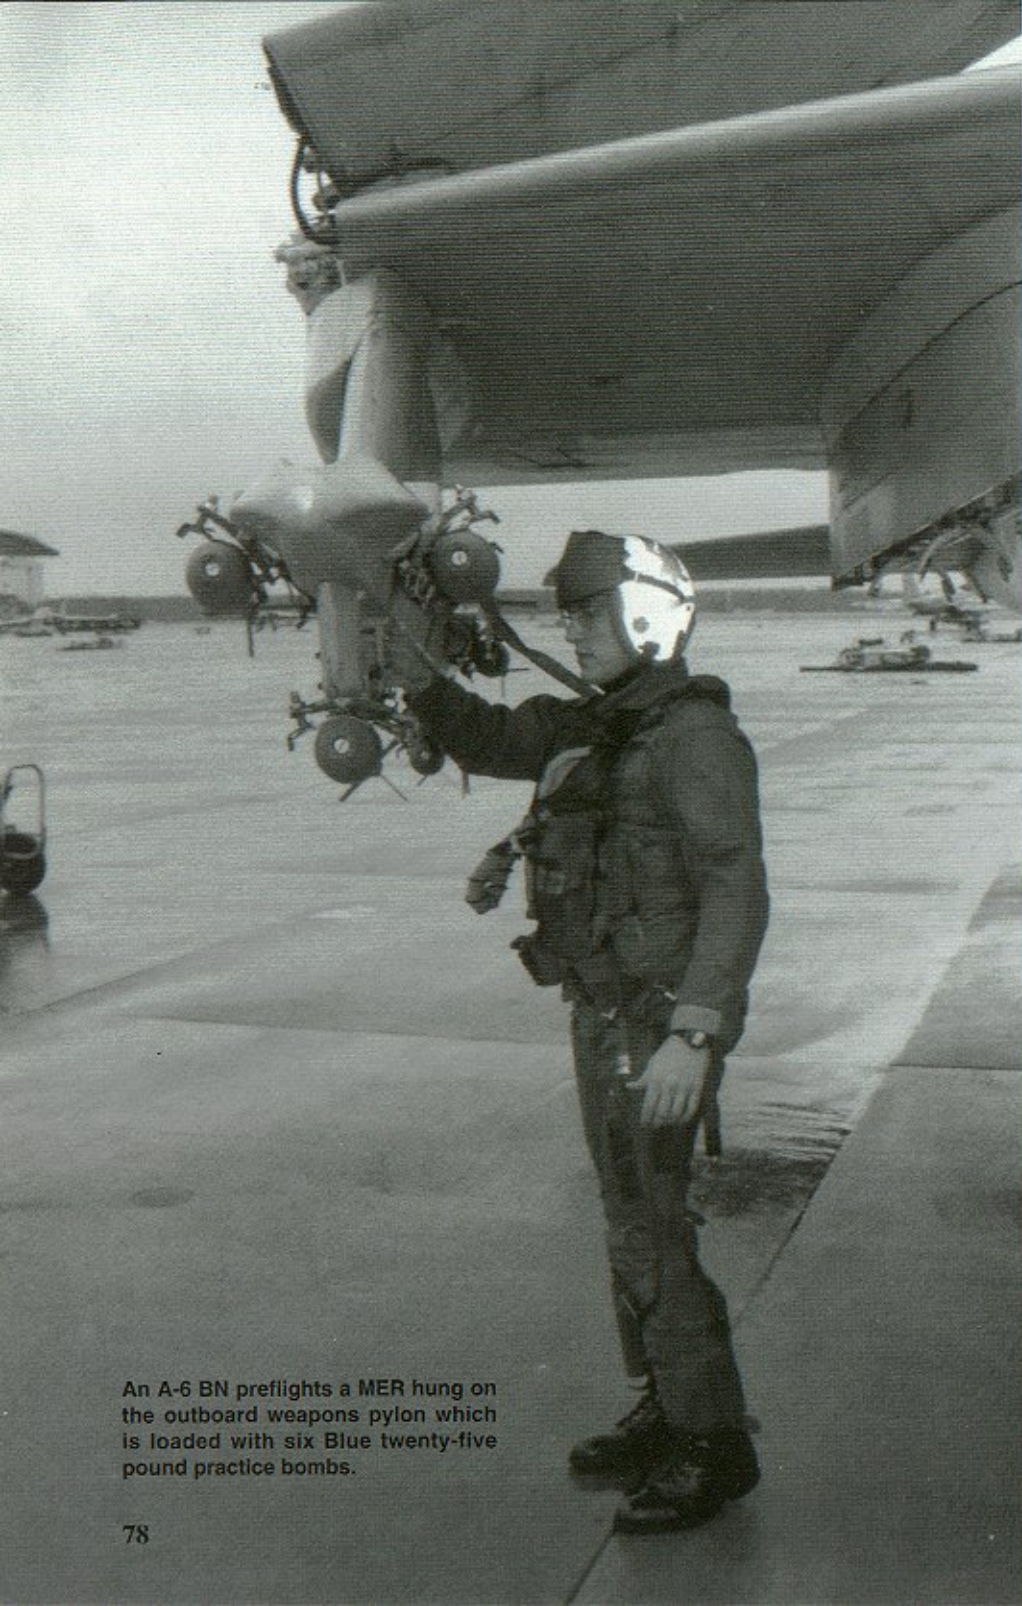
An A-6 BN preflights a MER hung on the outboard weapons pylon which is loaded with six Blue twenty-five pound practice bombs.

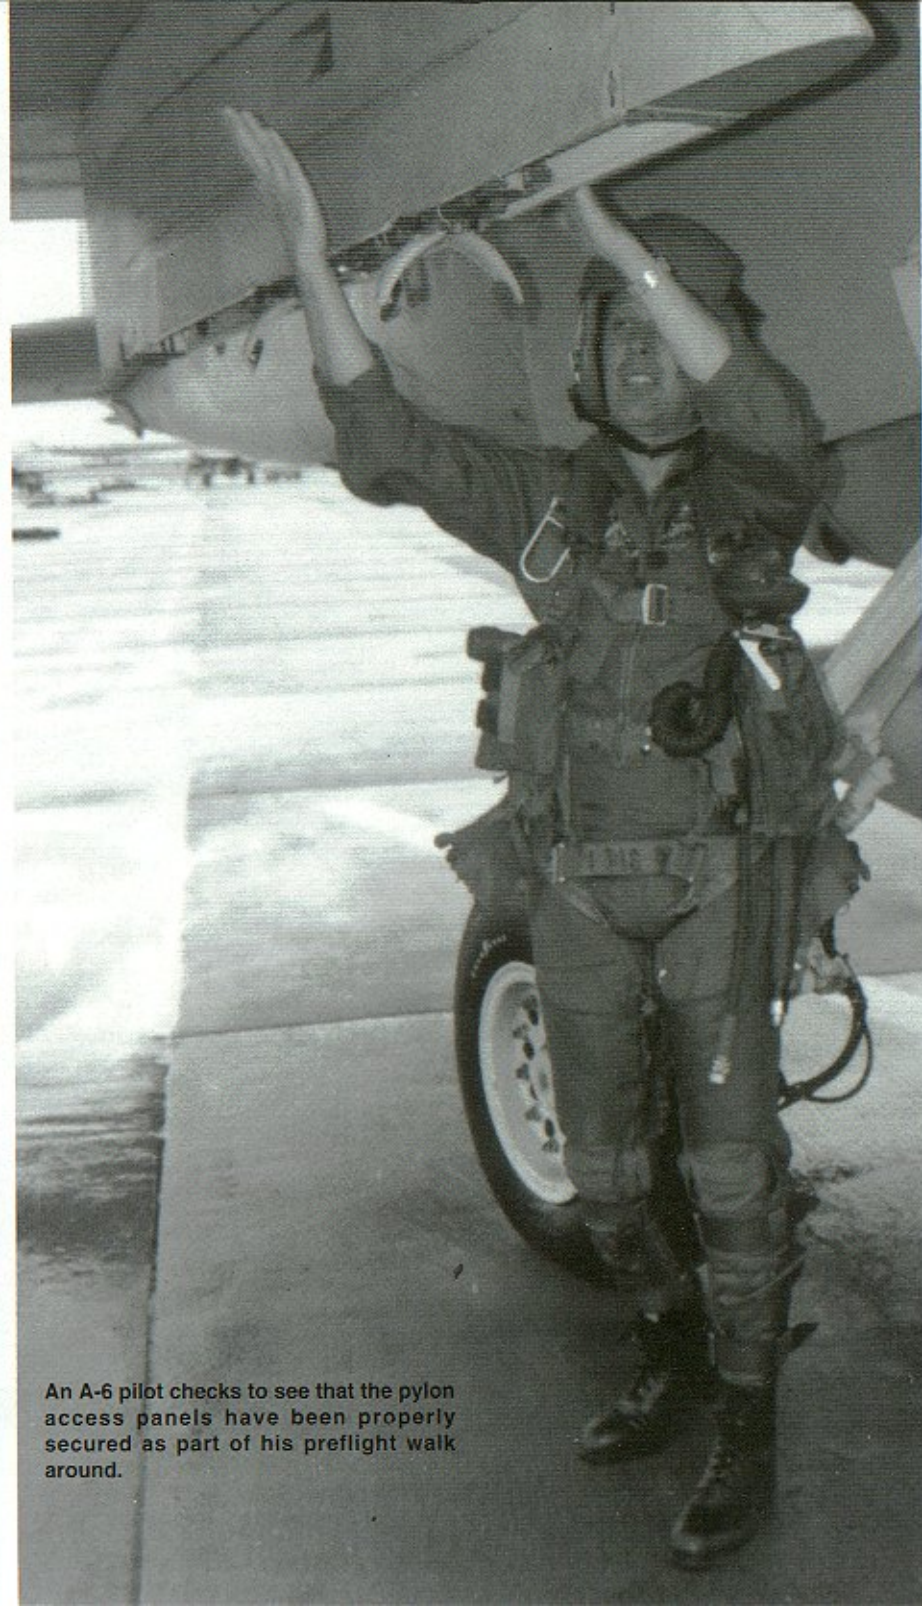
An A-6 pilot checks to see that the pylon access panels have been properly secured as part of his preflight walk around.

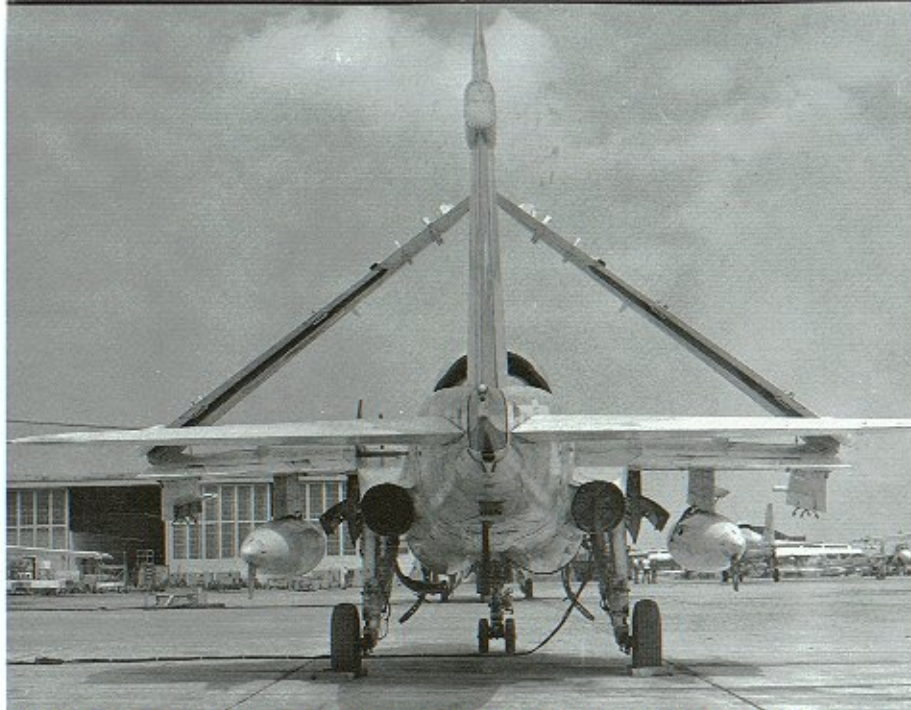
This A-6A is loaded with two 300 gallon external fuel tanks on the inboard pylons. The A-6 can carry these tanks on all five pylons for a ferry mission.

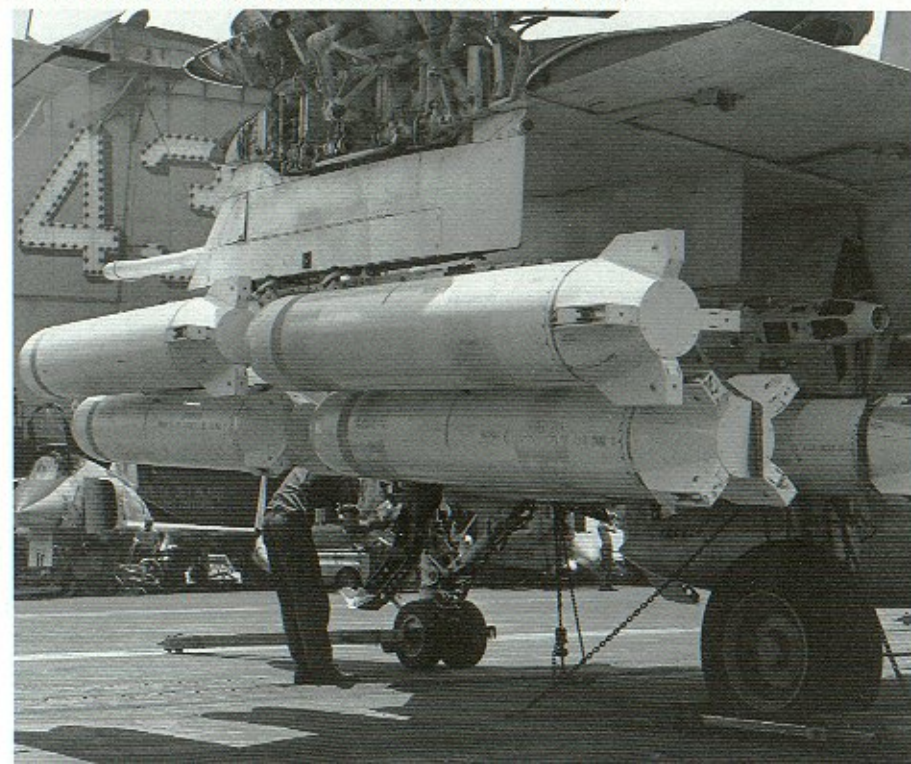
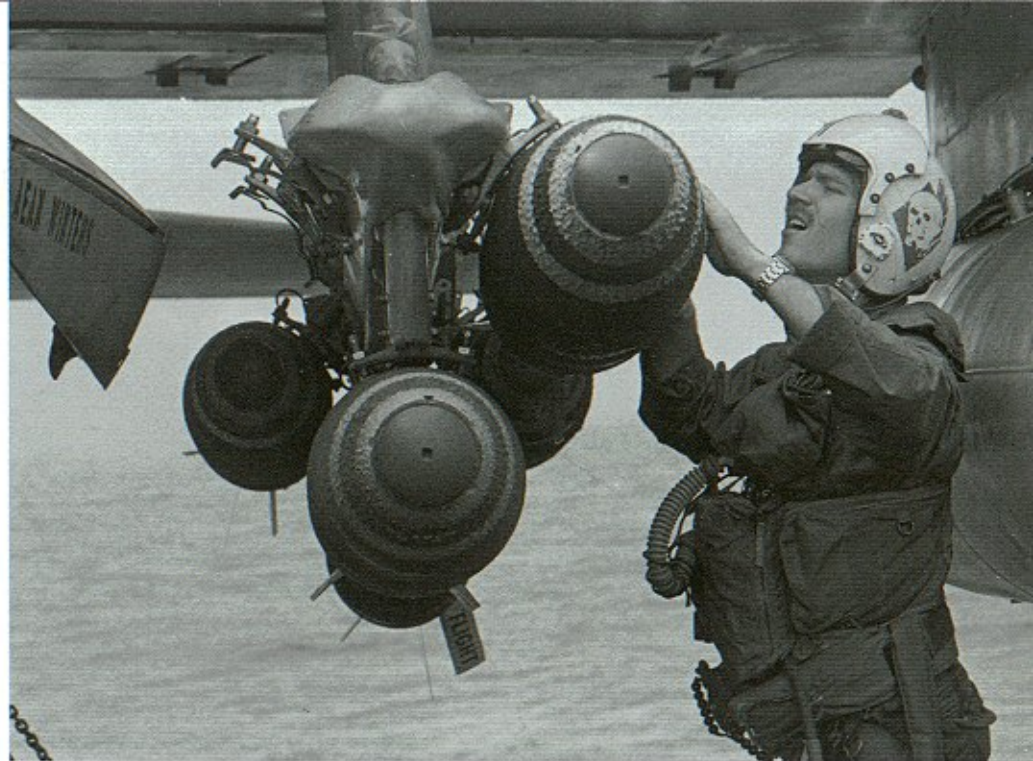
An A-6 crewman checks the Mk 82s on his A-6 aboard USS EISENHOWER (CVN-69). The MER is loaded with only five on the inboard pylon since the sixth would not clear the landing gear door.

This was the A-6E TRAM prototype. The antennas under the nose are the VHF communications (forward), UHF communications (second long antenna) and TACAN (last short antenna).
